**MANDATORY BULLETIN Z 242L/11a**

**Z 142C/ 7a**

1. **AFFECTED AIRCRAFT :** Z 242L aircraft S/N 541, 651-659  
Z 142C aircraft S/N 556-559
2. **SUBJECT :** At the extreme deflection of the nose-wheel steering the screw of the Spring-mechanism L 242.4217 may interfere with the nose-wheel strut body.

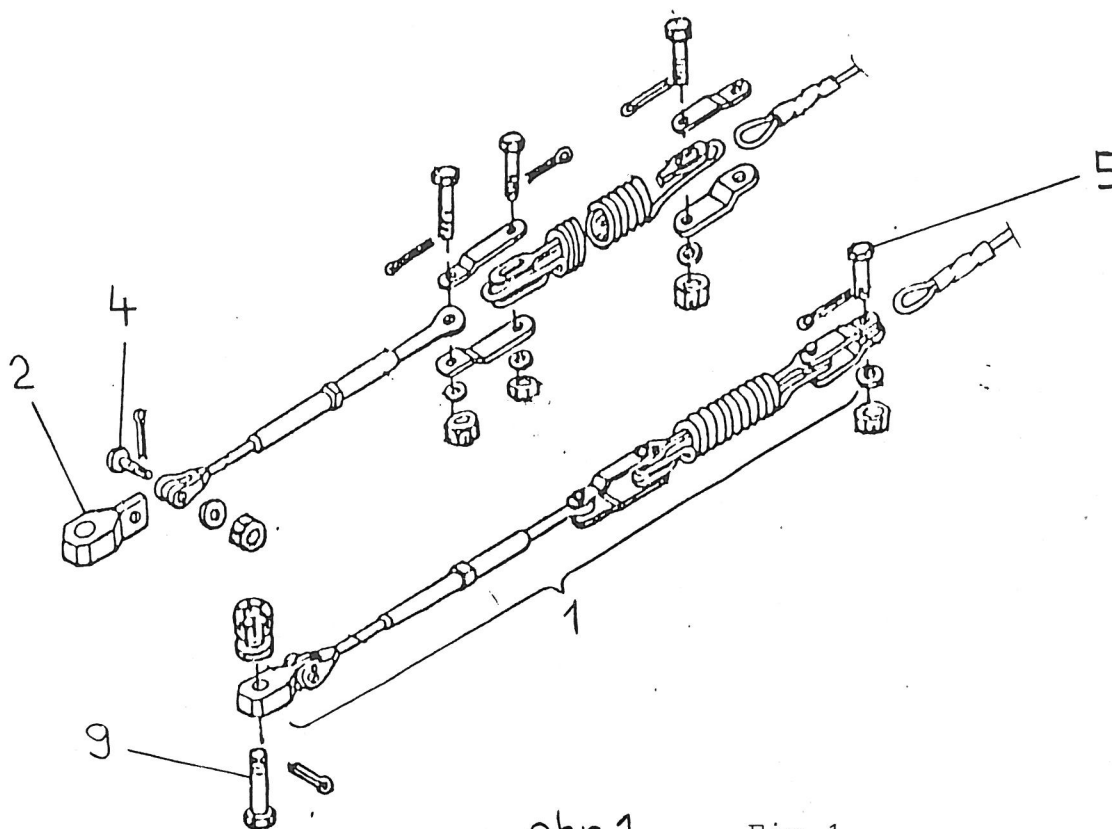
Fig.1

- the Operator.  
The material - the Manufacturer.
7. **PROCEDURE :**
  - a) Release the turnbuckle, remove the spring mechanism L 242.4217 (Item 1).
  - b) Remove the cube Z 42.4217-00.03 (Item 2).
