**ZLIN AIRCRAFT a.s.**  
Letiště 1578, 765 81 Otrokovice,  
Czech Republic  
e-mail: [zlin-service@zlinaircraft.eu](mailto:zlin-service@zlinaircraft.eu)  
<http://www.zlinaircraft.eu>

**MANDATORY BULLETIN Z 242L/10a**

Supersedes Service Instruction No. 1/94

2. **SUBJECT:** Unification of Manuals and application of an identical maintenance system for the Z 242L airplanes.
3. **CORRECTION:** 3.1 Replacement of the airplane Manuals by following ones, containing Revision No. 1 and all subsequent Revisions prescribed in corresponding Mandatory Bulletins (at the date of issuance of this Bulletin the following Mandatory Bulletins are applicable: Z 242L/12a (Z 242L/12a - Rev. 1), Z 242L/13a, Z 242L/14a and Z 242L/16a).

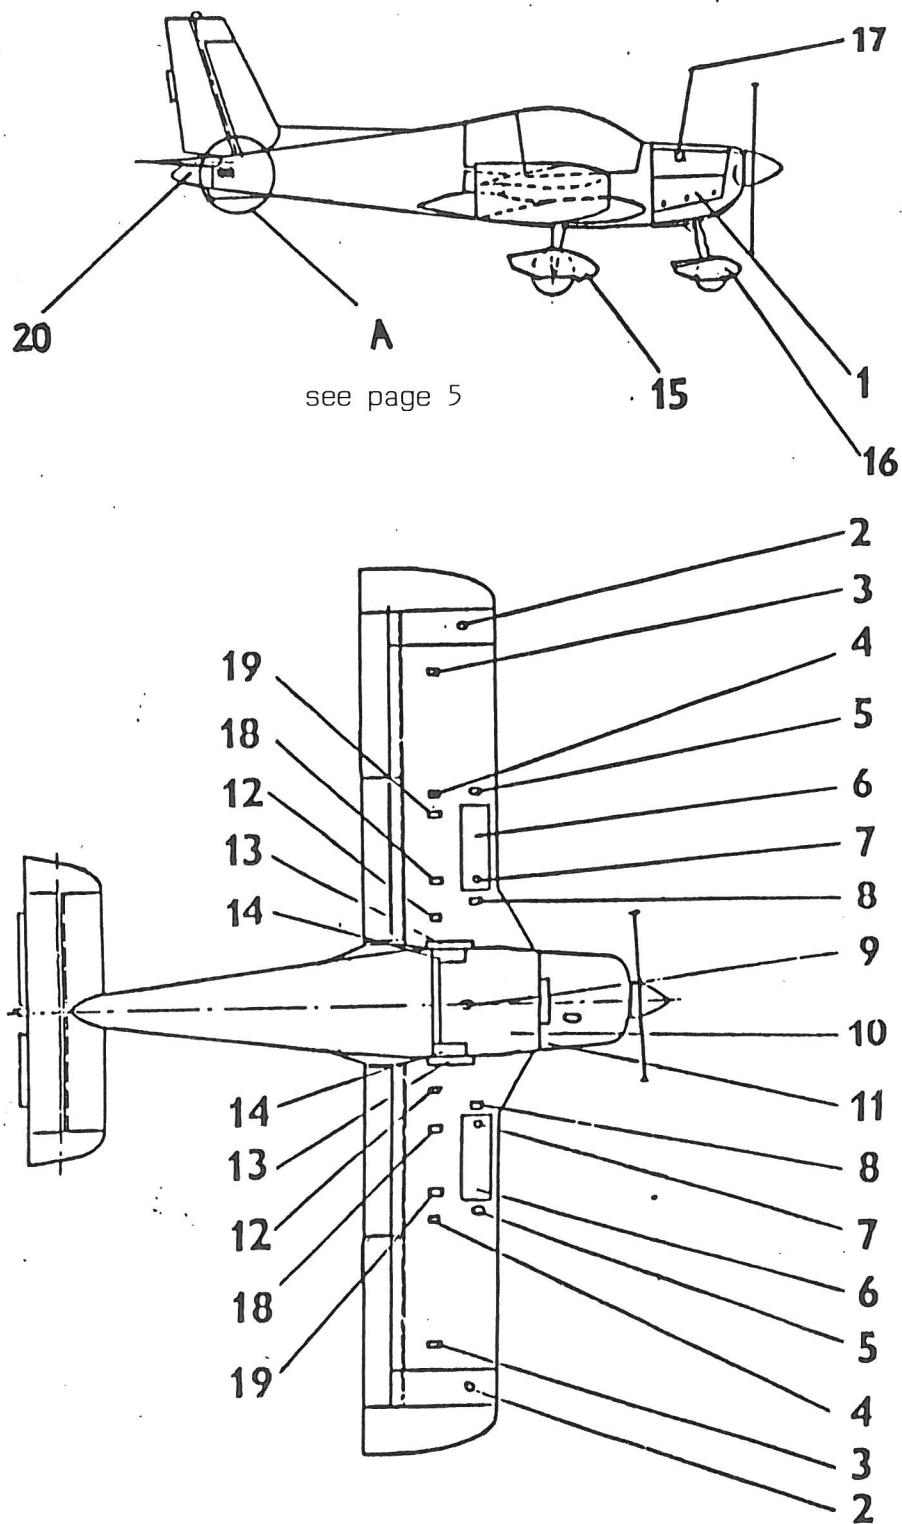
Covers and Lids -View from Right and Below

- i. Survey the four holes in the bottom skin of the l.h./r.h. wing behind the main spar between the ribs No. 3-4 and 6-7 respectively - see Fig. 1 through 3. Adjust the lid according to the survey and mark out the shape of the holes on the skin. Cut-out the holes carefully, use the rotary file to finish the correct shape.

- i. Remove rear cover pos. 20 below horizontal tail surfaces
- ii. Adjust the plate pos. 21 on the r.h. outer side of fuselage rear part skin above the fuselage rear part axis (above the pulley for trimming gear control cable) and in front of the last fuselage bulkhead.
- iii. Drill 4 holes 2.7 mm dia both into the plate and skin
- iv. Rivet the plate by 4 DuV 2.6x5 mm rivets
- v. Reinstall the rear cover pos. 20 on the fuselage rear part below horizontal tail surfaces.

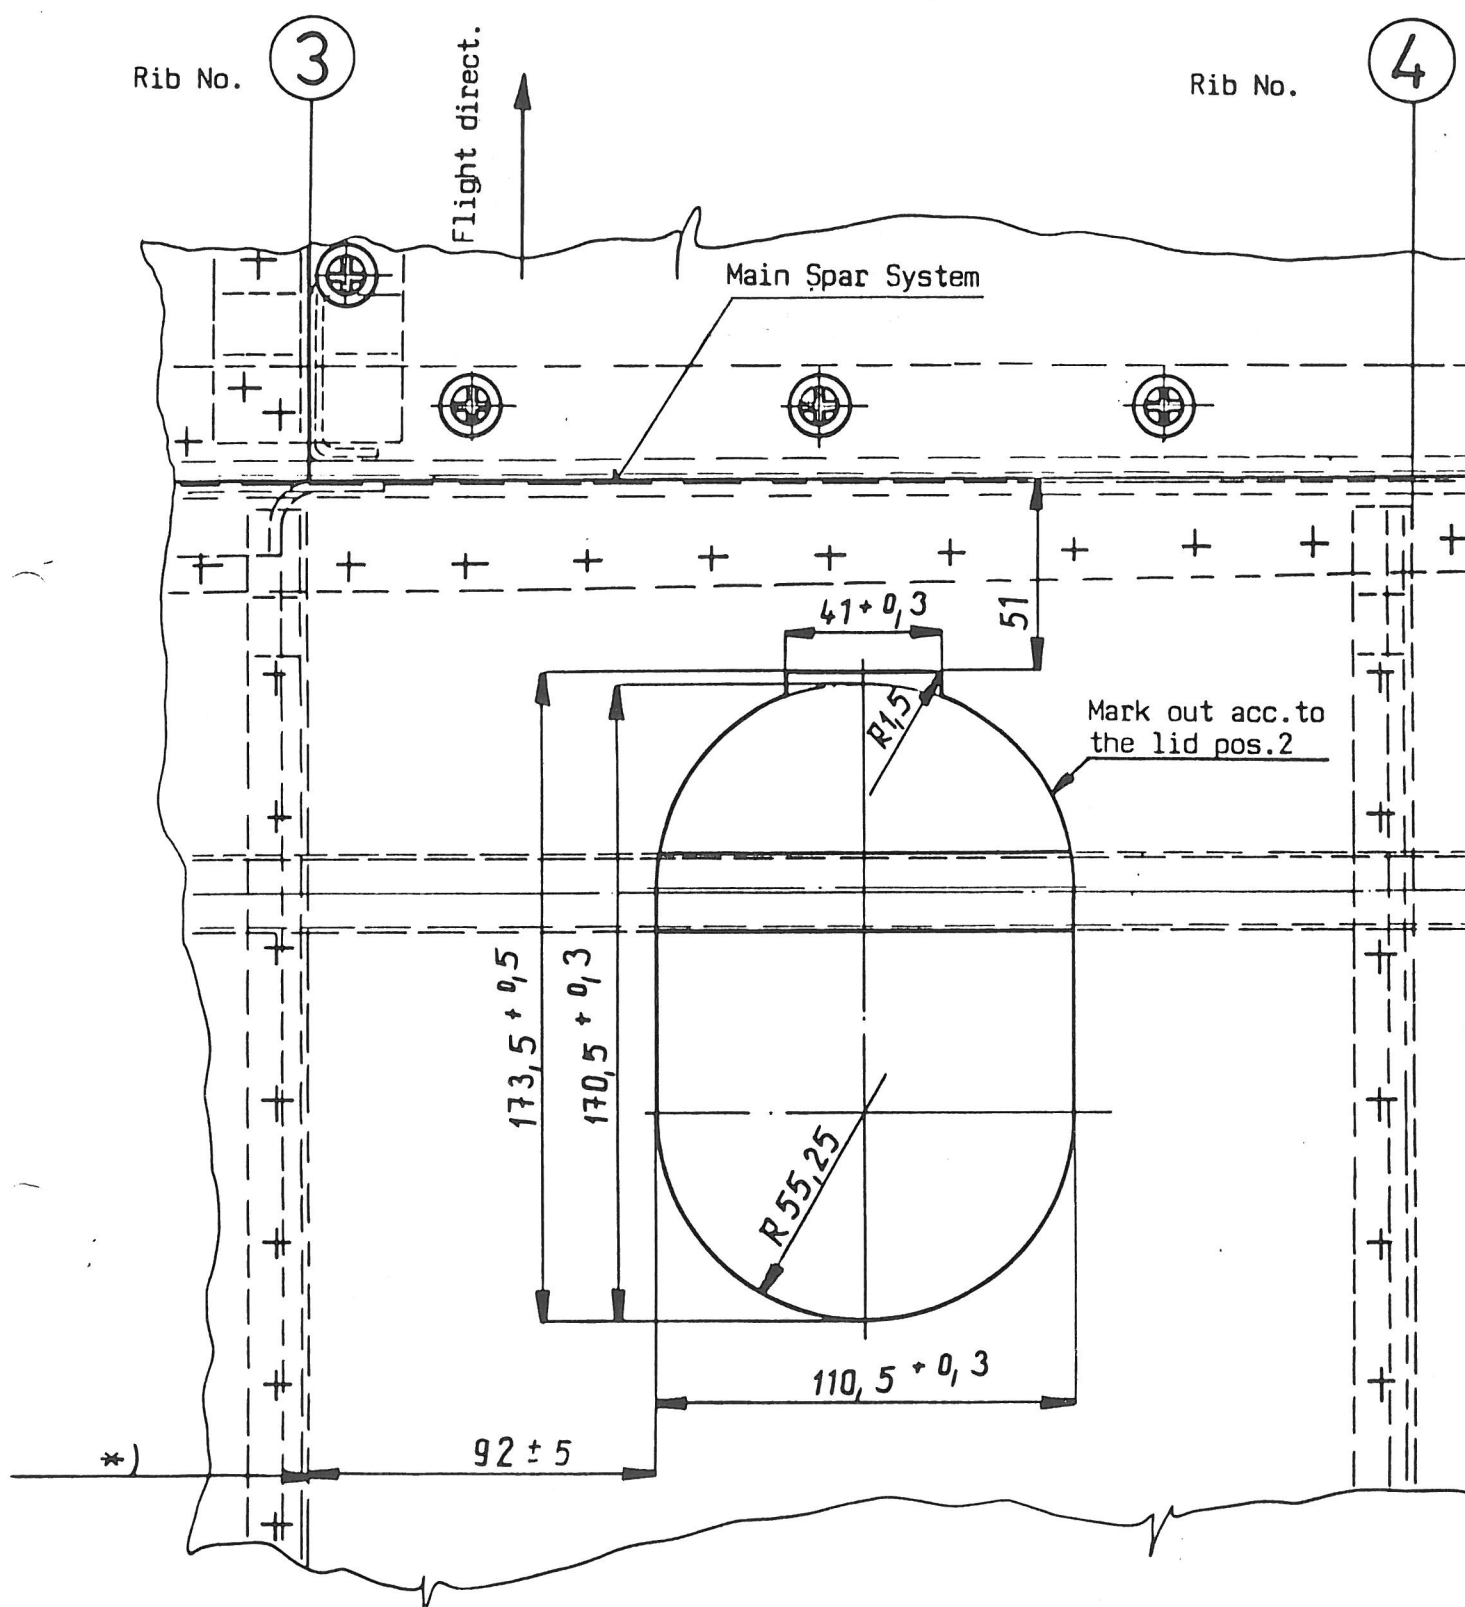
View on the bottom skin of wing

\* inf. 596 from the centre of the low hinge

Avoid the possible damage of inner parts during the cutting-out procedure! The lid spanwise positions, measured from the ribs No. 3 and 6 or from the centre of low hinge, are to be hold on the nominal values, shown in Fig. 2 and 3, in allowed tolerance  $\pm 5$  mm.

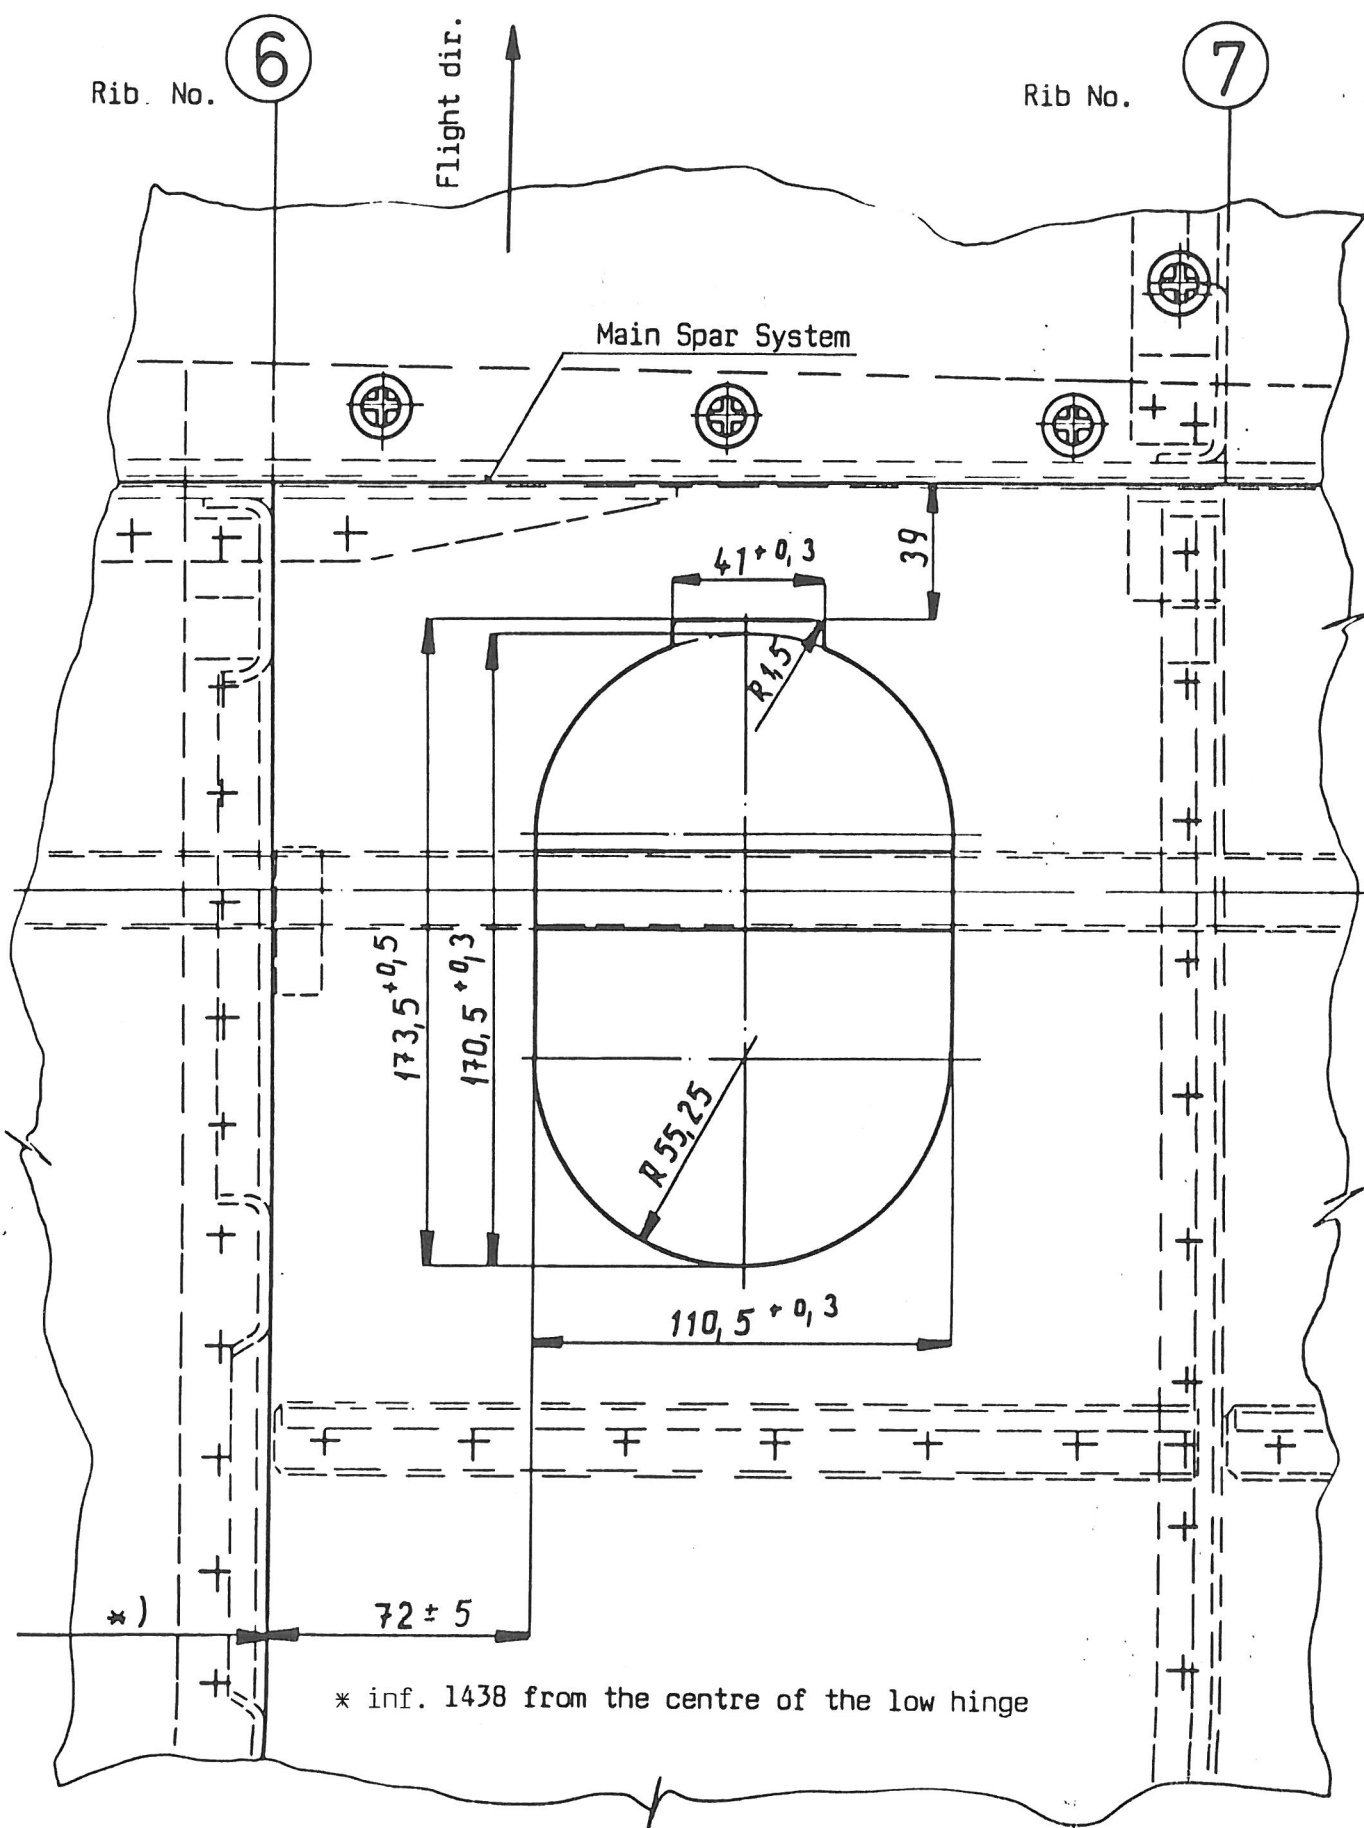
Fig. 3

View on the bottom skin of wing

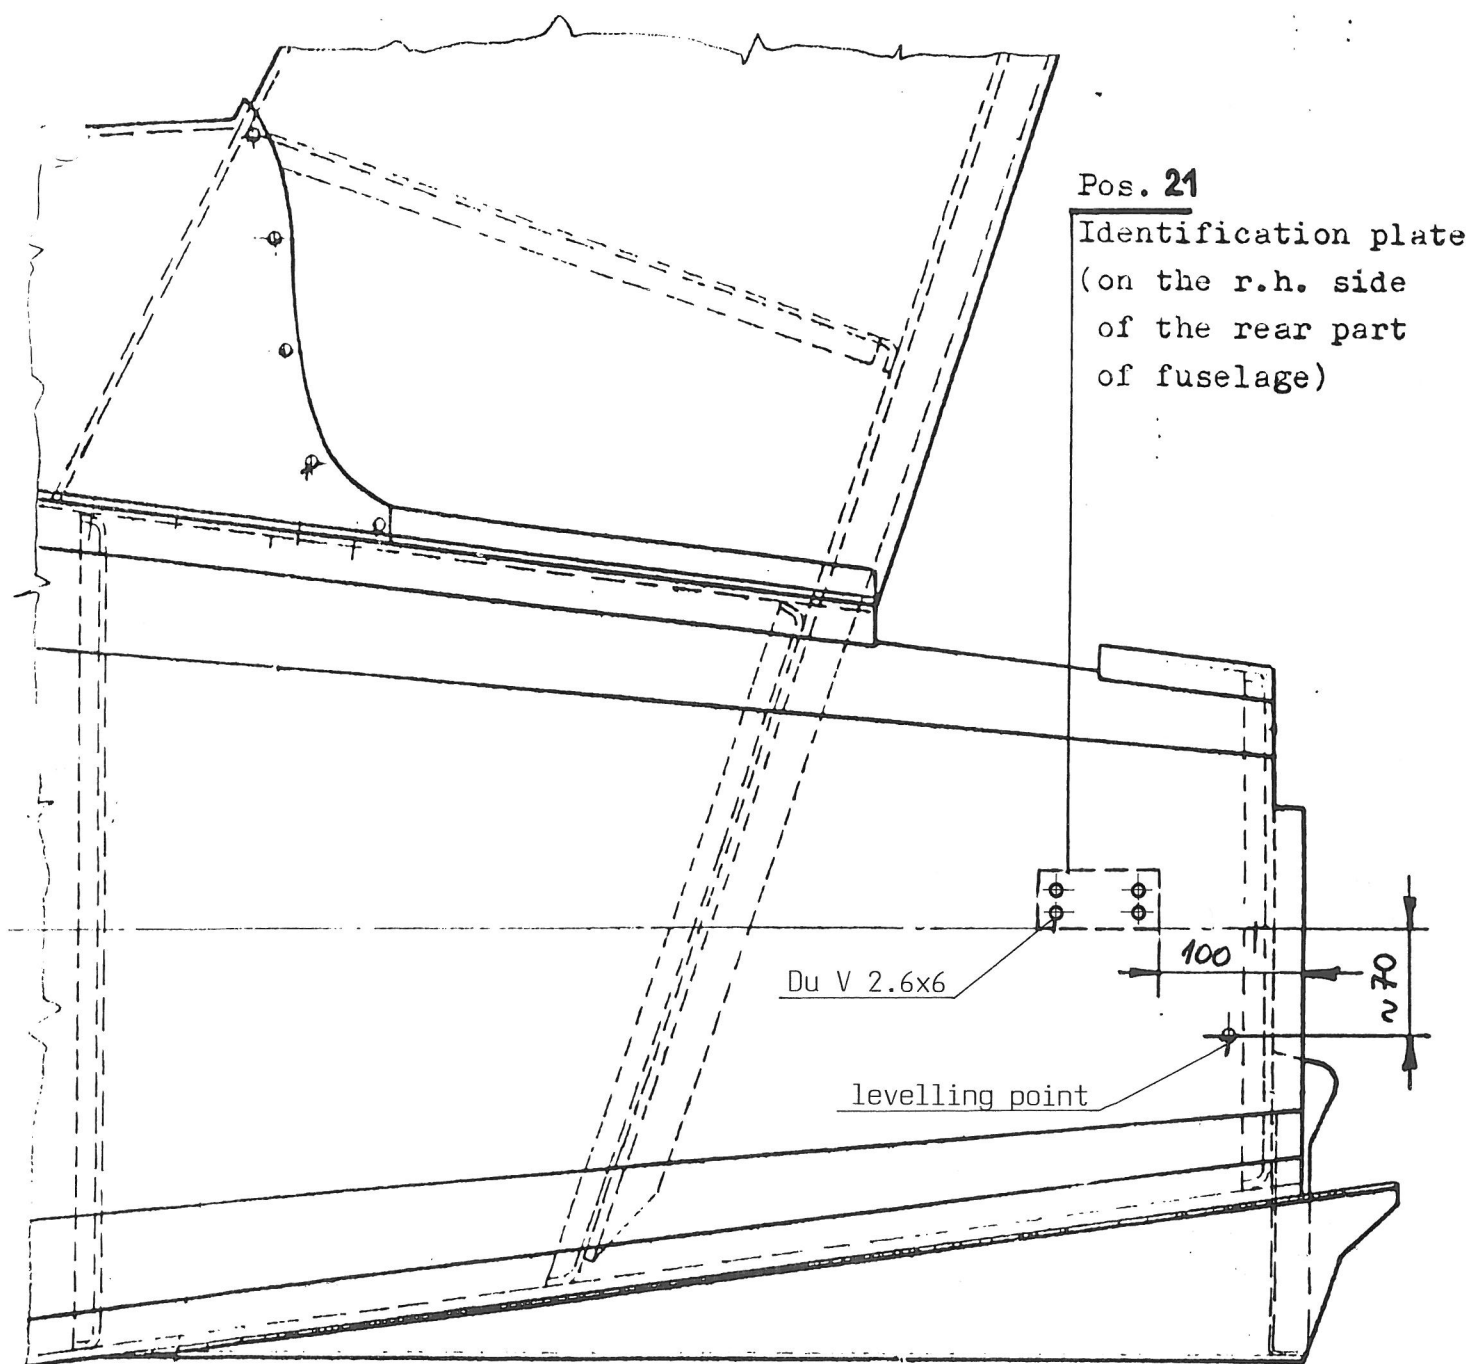
Fig. 5

Identification plate location
