**MANDATORY SERVICE BULLETIN Z 242L/15a**

- 1. MODELS AFFECTED:** All Z 242L aircraft up to S/No. 0676 incl.
- 2. SUBJECT:** Cracks on the exhaust muffler first chamber faces (Part/No. L 242.6671-01.00).
- 3. CORRECTION:**
  - 3.1. Check immediately the exhaust muffler faces for crack occurrence.
  - 3.2. Check regularly the exhaust muffler for cracks at the engine scheduled inspections after first 25 hours and then after every 50 hours of operation.
  - 3.3. In case of crack occurrence, optionally follow subsection 7.2. or 7.3. of this Bulletin.
- 4. TIME OF COMPLIANCE:**

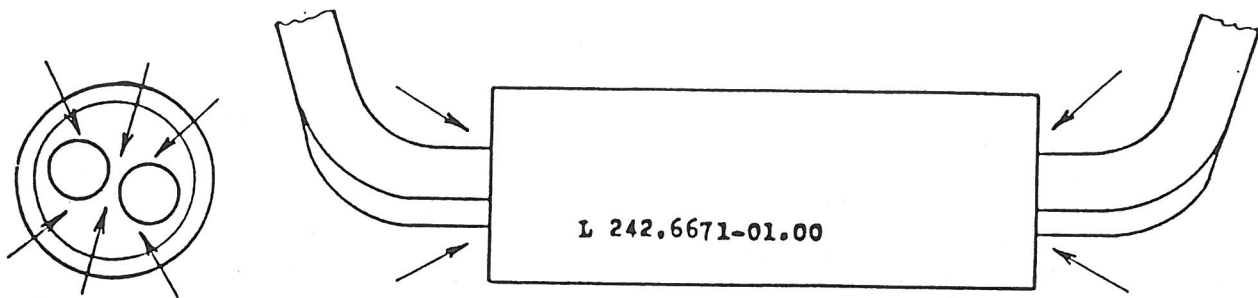
Fig. 1

- 7.1. Check visually the first chamber of the exhaust muffler Part/No. L 242.6671-01.00 with the magnifier (4x magnifying)  
- See Fig. 1.

→ checked area

- 7.2. After detecting any cracks, notify your Customers Service or the Manufacturer. A new or repaired muffler shall be sent you for replacement of the damaged one,  
or:
- 7.3. The user may repair the exhaust muffler himself if he complies with following conditions:
1. Use only the original parts delivered by the Manufacturer for repair.
  2. Follow a prescribed repair procedure.
  3. Observe the connecting dimensions of the exhaust muffler pipes/flanges.
  4. The repair must be accomplished by the properly authorised person (welder).
