**MANDATORY SERVICE BULLETIN No. Z 242/5**

1. Subject: All manufactured Z 242L airplanes including S/N 0659.
2. Reason: The correct function of the L242.1510-03.00 Bushing may be inadversely affected by the dimensional tolerances of parts.
3. Measures: In assemblies:  
L 242.7310 Central throttle control  
L 242.7500 Mixture control  
L 242.7700 Cooling flap control  
L 242.7800 Propeller control

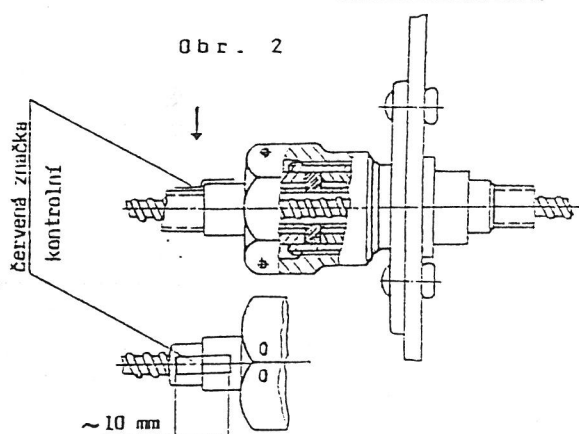
Obr. 2

During reassembly check carefully that both flexible rod tubes (from the engine and pilot compartment parts) are fully pushed - in the bushes, seating fully on the Ring faces according to Fig.2!

Let the Cap-nut and 1 piece of bush on the flexible - rod tube, pull - out the cable from the front tube, take out the "old" L242.1510-03.05 (2mm) Ring, insert the "new" L242.1510-03.06 (4,5mm) one.
