ZLIN AIRCRAFT a.s.

MANDATORY BULLETIN Z 242/9

All Z 242L aircraft.

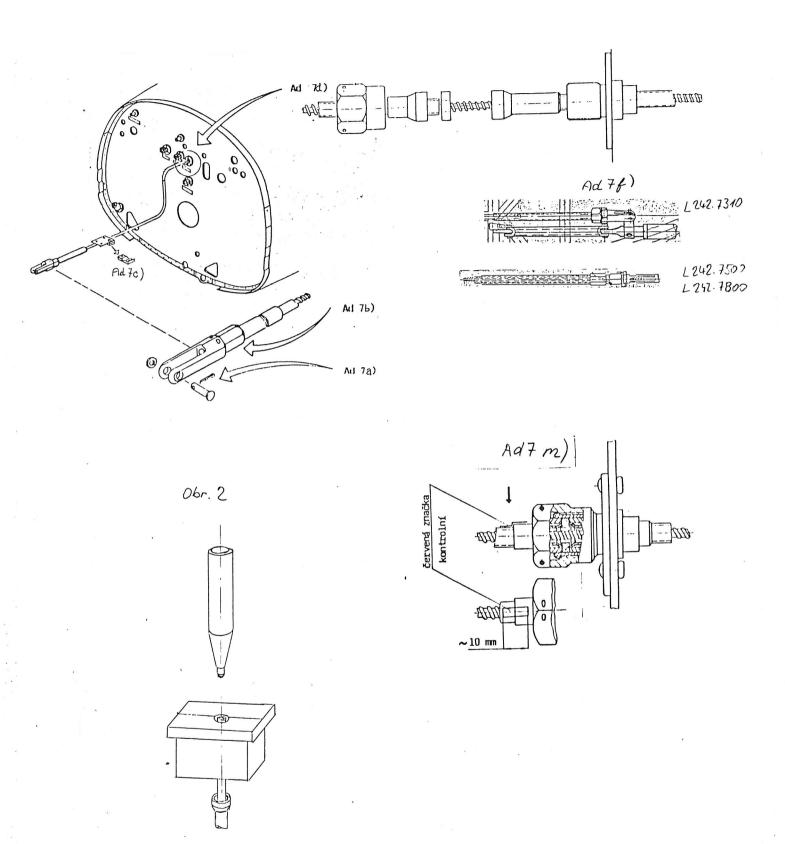
Excessive range of manufacturing tolerances can result in the limited or lost function of the clamped connection and consequently in slipping the teleflex tubes out from the bushing L 242.1510-03.00.

The central throttle control L 242.7310 The mixture control L 242.7500 The propeller control L 242.7800 carry out expanding the teleflex tubes ends inserted into bushing L 242.1510-03.00

in accordance with the Fig. 1.

- g) Put the cap nut and the insertion piece (15mm) on the front tube from the tube end inserted into the bushing (the tube end is marked with the centre mark and with the red colour See the Mandatory Bulletin Z 242/5). Clamp the tube into the expanding jig 003-430-081 and expand the tube end in accordance with the Fig.2.

Expand marked ends of the rear tubes according to the Fig.2, put the insertion pieces (25mm) on tubes.
- h) Pass the front tubes through the bushing from the engine compartment area to the area in front of the instrument board. Insert the teleflex cable with the teleflex clevis and with the guide /the teleflex cable with the coupling and with the guide into the bushing from the area in front of the instrument board to the engine compartment area. Connect the throttle pull rod/the mixture pull rod/ the propeller pull rod with the teleflex clevis and the guide/ the coupling and the guide according to the point f) in the reverse procedure.
