## MANDATORY SERVICE BULLETIN Z 50/36a, Z 50M/06a

All the Z 50LA, Z 50LS, Z 50LX, Z 50M

Cracks on welded fitting/lever of rudder

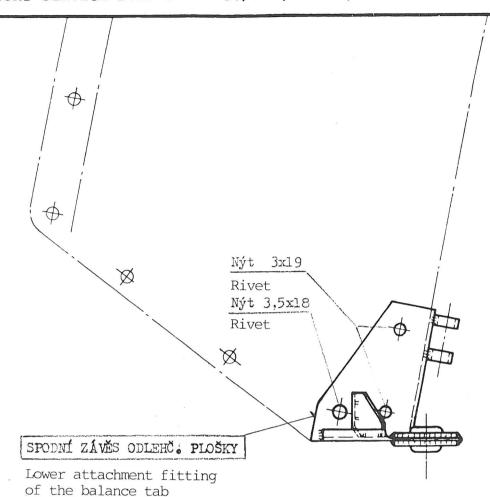
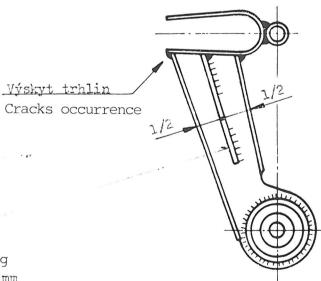
VÝZTUHA Reinforcing
Materiál: L-CM3.33, plech lmm
Material: L-CM2.33, sheet 1 mm

Svar TIG - použít wolframovou elektrodu a přídavný materiál Böhler DCMS-IG #1,6

"TIG" welding – use the tungsten electrode and the additional material BÖHLER DCMS-IG"  $\emptyset$  1.6
