**SERVICE  
BULLETIN**

MANDATORY SERVICE BULLETIN Z 126, Z 226/32a - Rev.1  
Z 326/86a - Rev.1  
Z 526/69a - Rev.1  
Z 726/19a - Rev.1

1. DATE: April 25, 1998
2. MODELS AFFECTED: All Z 126, Z 226B, Z 226T, Z 326, Z 326A,  
Z 526, Z 526A, Z 526AS, Z 526F, Z 526L,  
Z 526AFS, Z 726 and Z 726K aircraft.
3. SUBJECT: Sporadic occurrence of corrosion on the main  
wing spar flange plates.
4. CORRECTION: Visually check the wings in area of the main  
spar.  
The wings attacked from corrosion must be put  
out of operation.
5. TIME OF COMPLIANCE: a) Before next flight.  
b) Before first take-off of airplane with  
wings in which this bulletin was not  
accomplished.

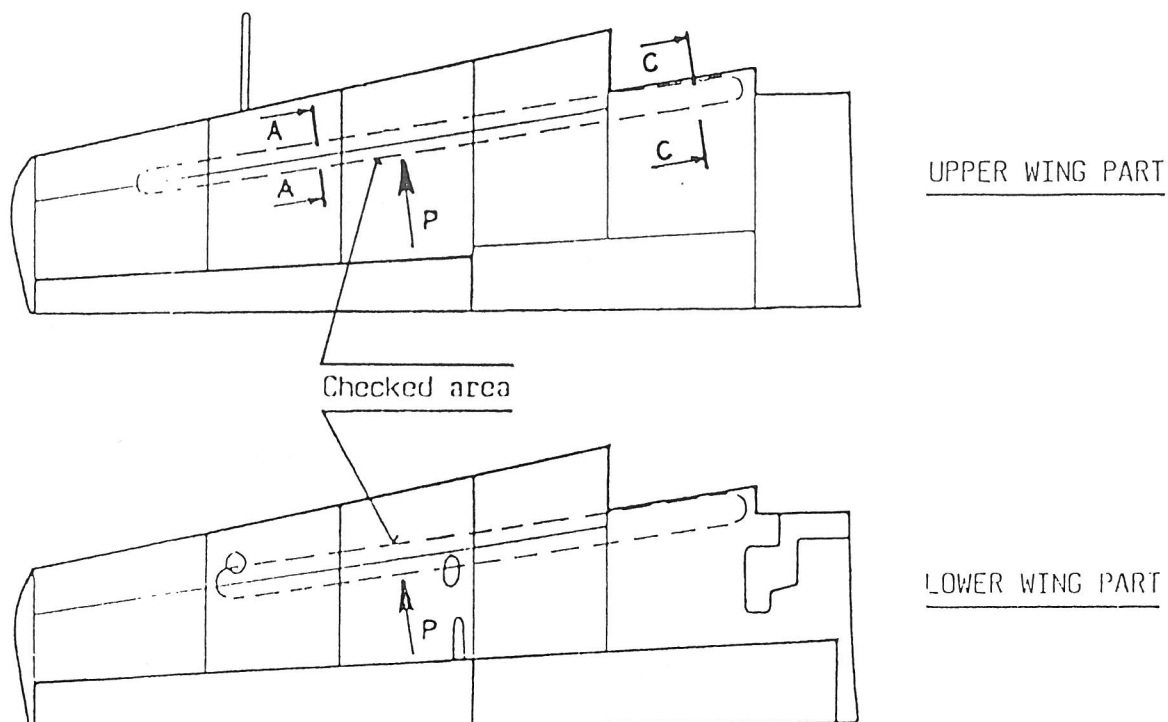
a) Check surface of the upper and the lower wing part in the main spar area:

Local corrosion occurred on the outside of angle, that creates the wing spar flange plate (see Section A-A), is reliably detectable at view in direction "P" (see Figure of Wings) because the exfoliation corrosion occurrence is shown by the skin sheet concavity on the rivet row (see Section B-B) that is caused by the attacked area swelling. Also there may be the rivet heads loosened considerably in attacked area.

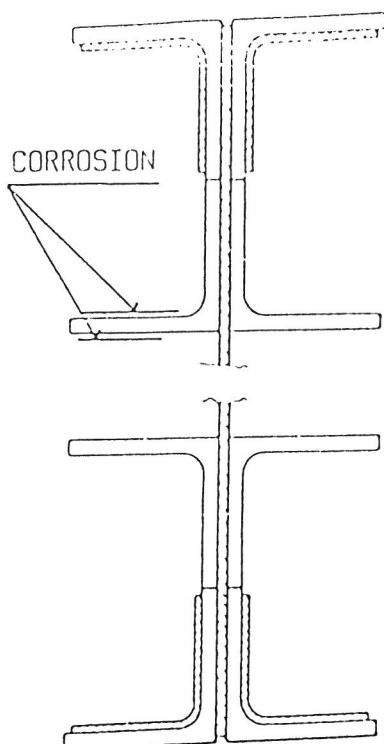
SECTION C-C

- b) Check of the main wing spar flange plates inside of the wing root part:  
Drain off the fuel, remove fuel tanks and visually check surface of angles of upper and lower flange plates (see Section C-C). To enable the check, tear off the cloth blinding stops on the wing structure precluding access to the checked spots.
- c) Unless the corrosion presence is proved by checking, replace torn-off cloth blinding stops with the new ones and re-install fuel tanks.  
Enter the result of check into the Aircraft Log-Book.
- d) If the main spar flange plate is attacked from corrosion, the wing must be put out of operation because its repair is impossible.
