## SERVICE LETTER No. L 118

**APPLICABLE TO:** Z 242 L aircraft S/N 0817, 0818, 0825, 0827

**REASON:** **Repair of broken console for vent pipe fixing**

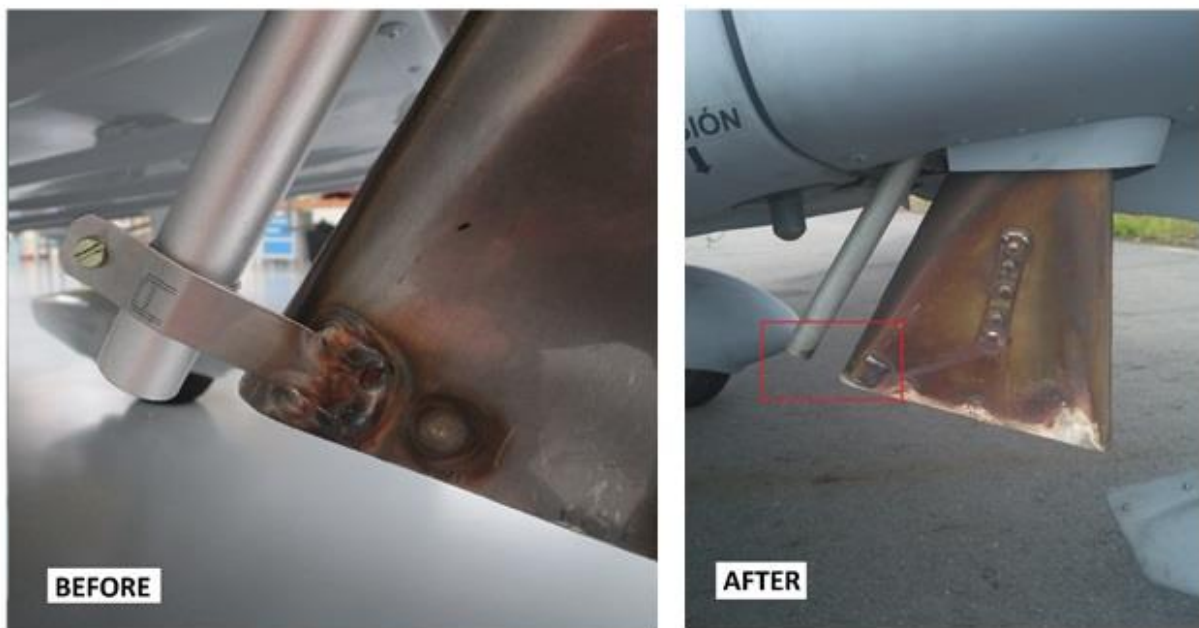
If the plate broke off acc. to Fig. 1-1 (originally welded in Exhaust silencer II assembly – L242.6674H) perform the following correction method:

*Fig. 1.1 Problem of the broken original Console L242.6674-00.17C*

- 1) It is necessary to use a new spare part Console, Drwg. No. L242.6674-00.17C, original part Clamp, including original fasteners, stainless connection material (2 pcs. screw, nuts, washer)
- 2) If necessary, perform grinding inequalities in place of the broken console.
- 3) Subsequently, place the plate on the Exhaust silencer II as shown in Fig. 1-2, perform the drill both plates with the drill  $\text{\O} 4.3 \text{ mm}$ .
- 4) Assemble the Console and plate of Exhaust silencer II with a screw connection, and LOCTITE can be used for additional locking.

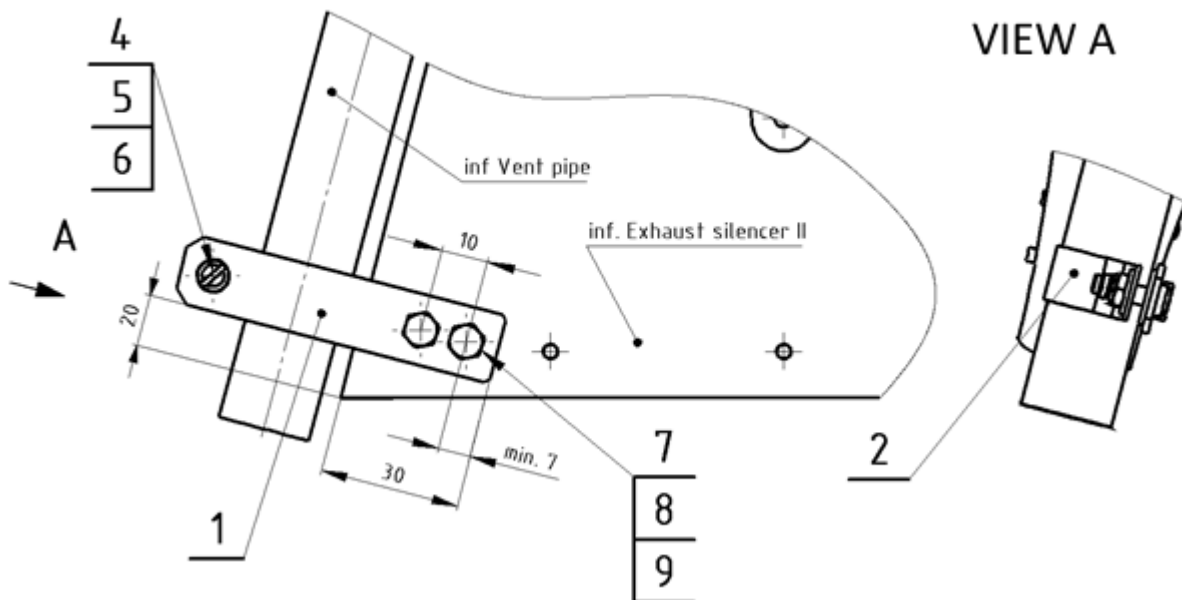
*Fig. 1-2 Illustration of repair on the Exhaust silencer II*
